## **BOREHOLE DRILLING PROGRESS REPORT**

**Submitted By: Villages in Partnership**

This Borehole Progress Drilling Report presents a comprehensive update of the borehole drilling project underway in Traditional Authority Nkagula, Zomba District. The project is funded by the Rotary Club of Downers Grove and implemented by Villages in Partnership (VIP).

The report covers geophysical surveys, borehole drilling, test pumping and civil works (headworks) construction. It specifically provides detailed progress on civil works for all five successful wells: Maliwata, Mwala, Manduwasa, Makuluni and Nsenda villages.

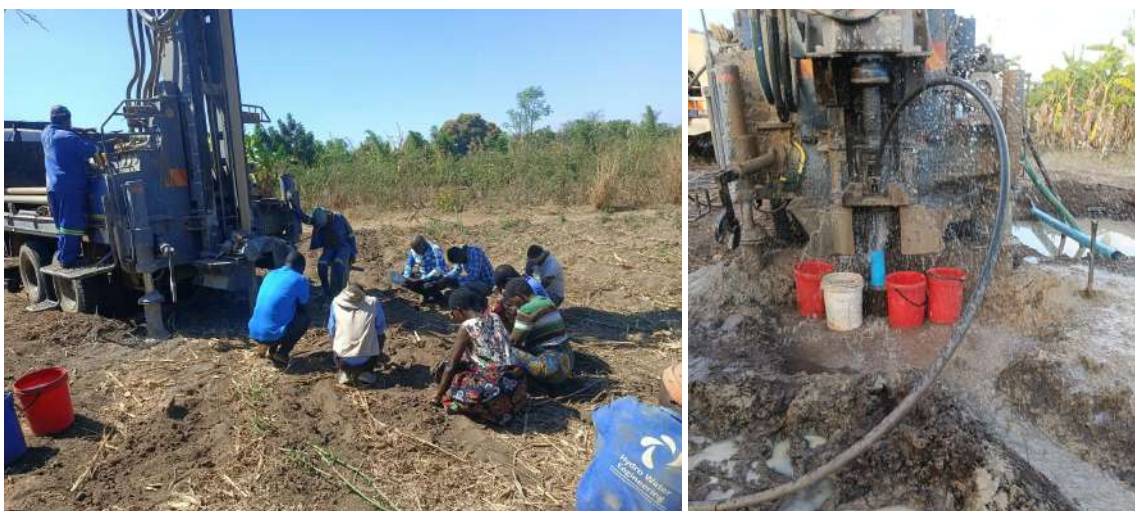
*Pictorial presentation: Left-Community members praying before commencing drilling of a borehole on the second site of drilling in Makuluni Village and Right-Borehole development in progress in Makuluni Village after a successful drilling*

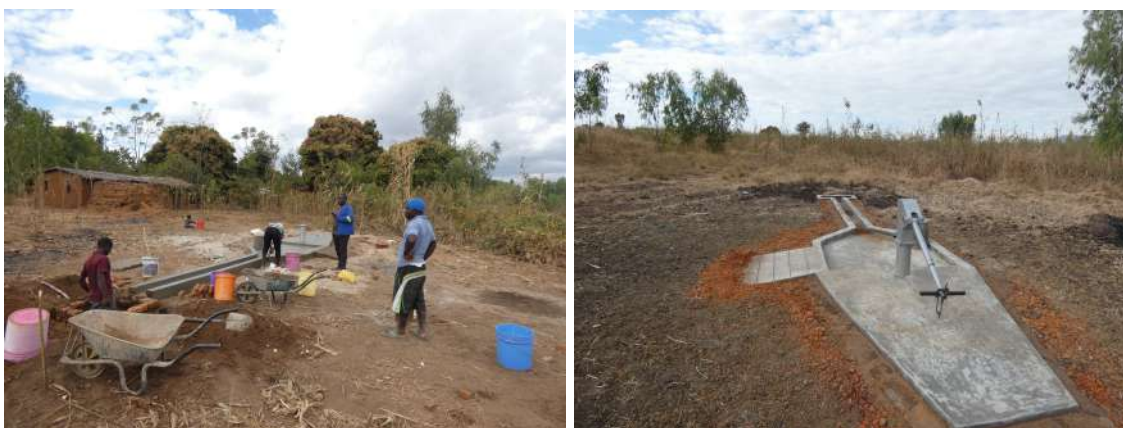
*Pictorial presentation: Left- Civil works progress in Nsenda village and Right-Completed borehole in Maliwata Village.*

Following successful drilling and test pumping, civil works (headworks) construction was carried out on all five successful boreholes: Maliwata, Mwala, Manduwasa, Makuluni and Nsenda. Works were completed in accordance with the Government of Malawi Technical Manual for Water Wells and Groundwater Monitoring Systems (MoAIWD, 2nd Edition, Feb 2019) – Chapter 4.2 Civil Works (Headworks) Construction for Afridev Handpump.
